Manhole Inspection Summary

Manhole # S31AA_030MH

Insp Date: **12/14/07 11:48 AM**

Location Address: **445 ORCHARD ST**

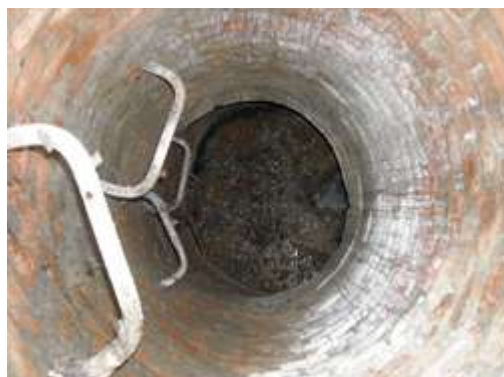
Top View

TOP VIEW DOES NOT SHOW
CONNECTIVITY DUE TO CHANNEL
JUNCTION OFFSET.

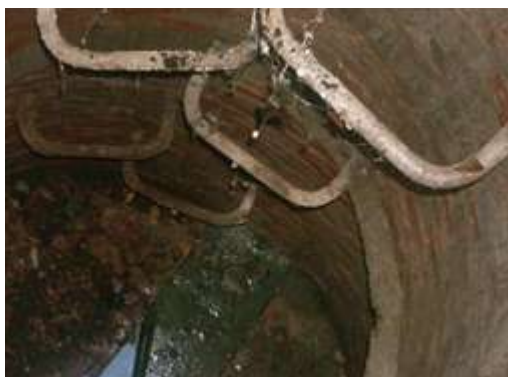
Defect 3

Count: **5** Missing: **0** ☒ **Corroded**

CORRODED STEPS

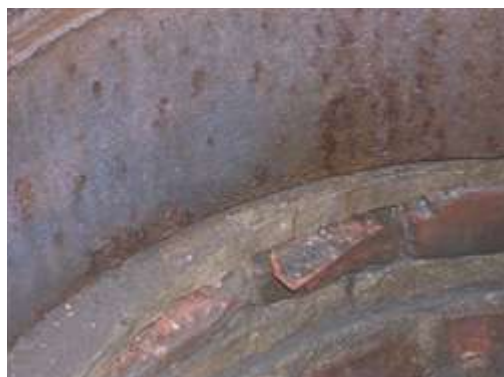
Defect 2

Condition: ☐ Sound ☐ Cracked ☐ Root Intrusion ☐ Loose Brick ☒ **Deteriorated**

CHIMNEY DETERIORATION

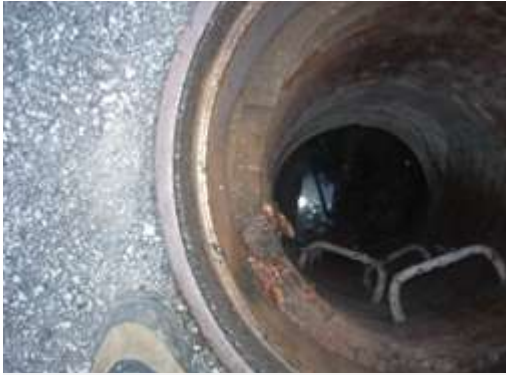
Defect 1

Offset: **2** (in.)

FRAME OFFSET

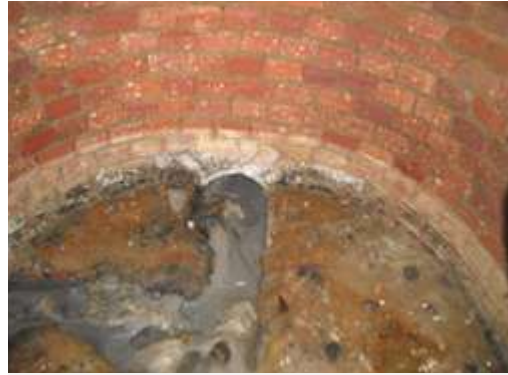
Defect 4

Condition: ☐ Sound ☐ Cracked ☐ Root Intrusion ☐ Deteriorated ☐ Leaks ☒ **Debris**

☒ **Evidence Of Surcharge** Depth: **1.5** (ft.) ☐ Active Surcharge Present

EVIDENCE OF SURCHARGE TO 1.5',
DEBRIS ON BENCH

Comments **TOOK NEW PHOTOS - TOP VIEW DOES NOT SHOW CONNECTIVITY DUE TO CHANNEL JUNCTION OFFSET. UPDATED SURCHARGE CONDITION. CLEANING REQUIRED COULD NOT GET NEW I9 PHOTO.**

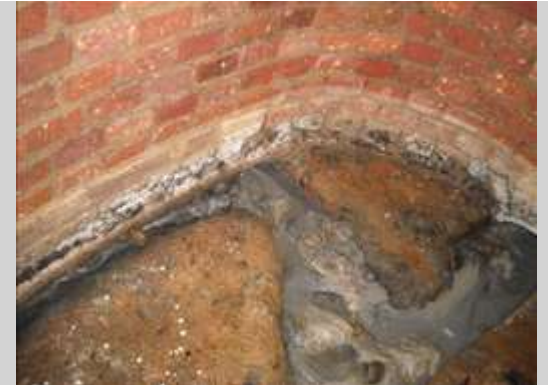
12 O'Clock Outflow

Pipe Height: **8.4** (in.) Rod and Bar (Angled)
Pipe Material: **Clay** ☐ Pipe Lined
Invert Depth: **11.99** (ft.) Flow Characteristics: **Slow**
Deposits: ☐ None ☐ Mud ☒ **Sludge** ☐ Debris ☐ Grease
Silt Depth: **6** (in.) Deposits Extent: **Heavy**
Infiltration: **None** Pipe Seal Cond: **Sound**

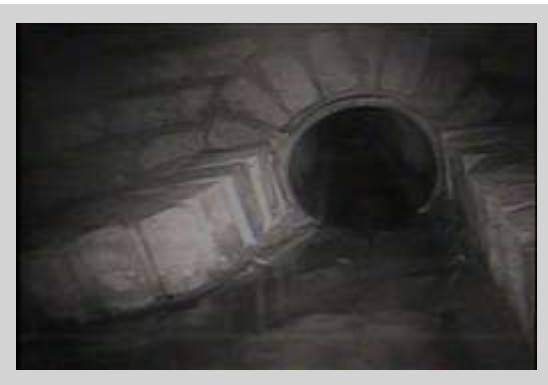
3 O'Clock Inflow

Pipe Height: **8.4** (in.) Rod and Bar (Angled)
Pipe Material: **Clay** ☐ Pipe Lined
Invert Depth: **11.79** (ft.) Flow Characteristics: **Slow**
Deposits: ☐ None ☐ Mud ☒ **Sludge** ☐ Debris ☐ Grease
Silt Depth: **4** (in.) Deposits Extent: **Medium**
Infiltration: **None** Pipe Seal Cond: **Sound**

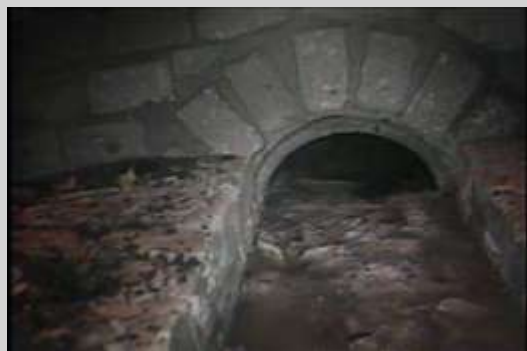
9 O'Clock Inflow

Silt Depth: **5** (in.) Deposits Extent: **Heavy**
